**SUBJECT:** Transmittal of Final Report - High Lead at Three Residences in Flint, Michigan

## High Lead Levels in Flint, Michigan

The purpose of this report is to present the findings of activities conducted in response to high lead levels in drinking water reported to the United States Environmental Protection Agency Region 5 Office (EPA) by a resident in the City of Flint, Michigan.

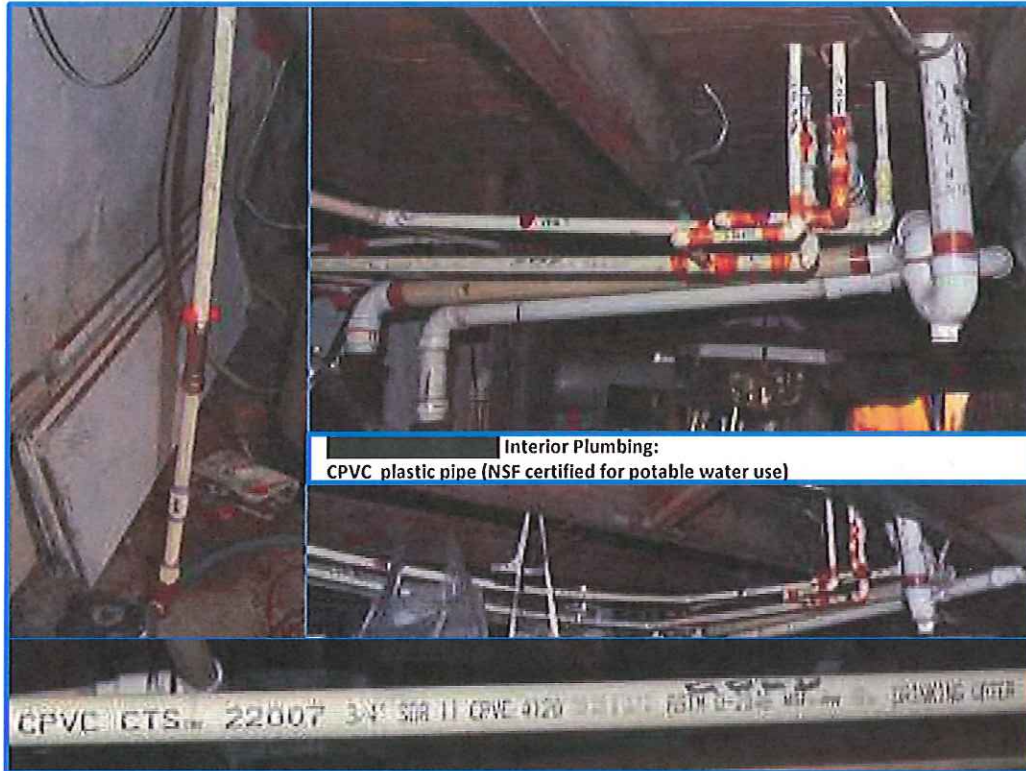
**Internal Plumbing – [REDACTED]**

The following pictures were taken at the [REDACTED] home located at [REDACTED]. With the exception of a few minor metallic connectors, all potable water plumbing in the home was found to be CPVC plastic pipe which is NSF-certified for drinking water use.

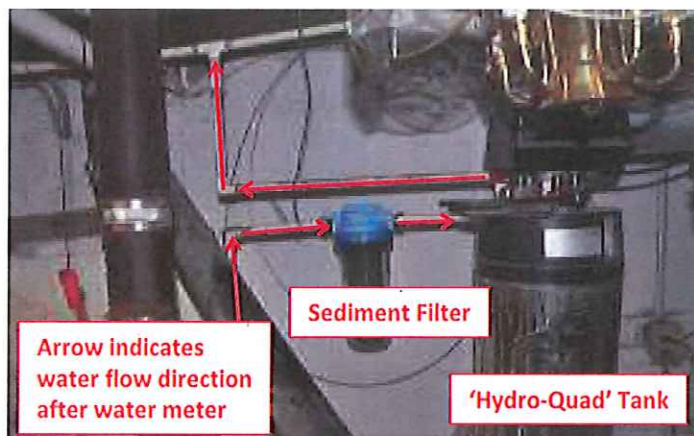
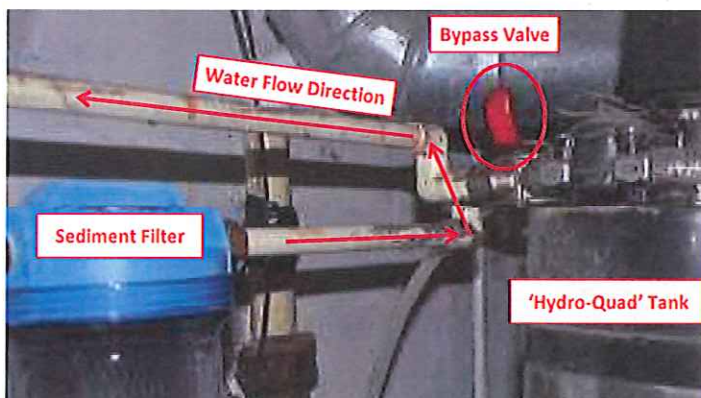
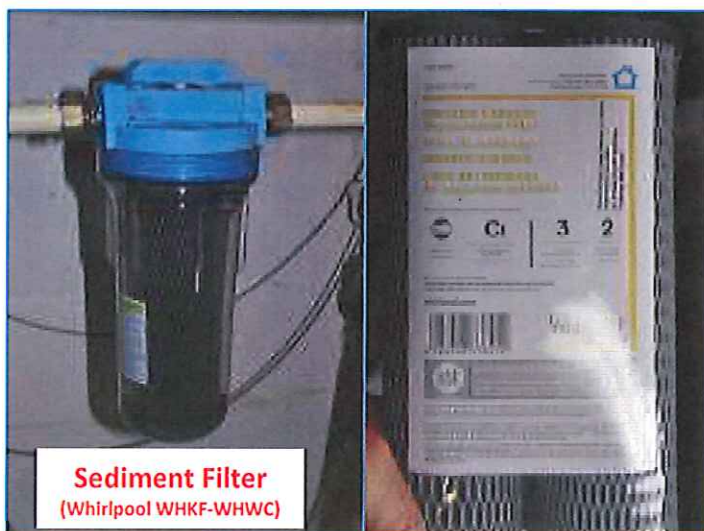
**Treatment Units –** [REDACTED]

The [REDACTED] home has a whole-home sediment filter, as well a non-functioning 'Hydro-Quad Commercial Water Processor' which is bypassed. There was no iron filter in the home as had been previously reported.

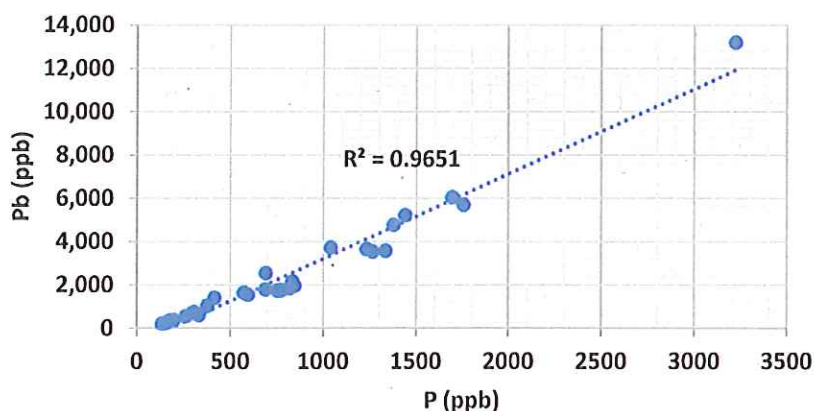
#### Correlation between Pb and P (Samples M-1 through M-32)

The correlation of lead and phosphate, as well as lead and aluminum, indicate that the samples were captured scale and sediment that had formed inside the pipes while the City of Flint was purchasing water from Detroit. The absence of these chemicals in the current treatment provided by Flint indicate that these elements were not in the water passing through the pipes, but came from the scales inside the service line which had disintegrated into the water or were dislodged into the water.

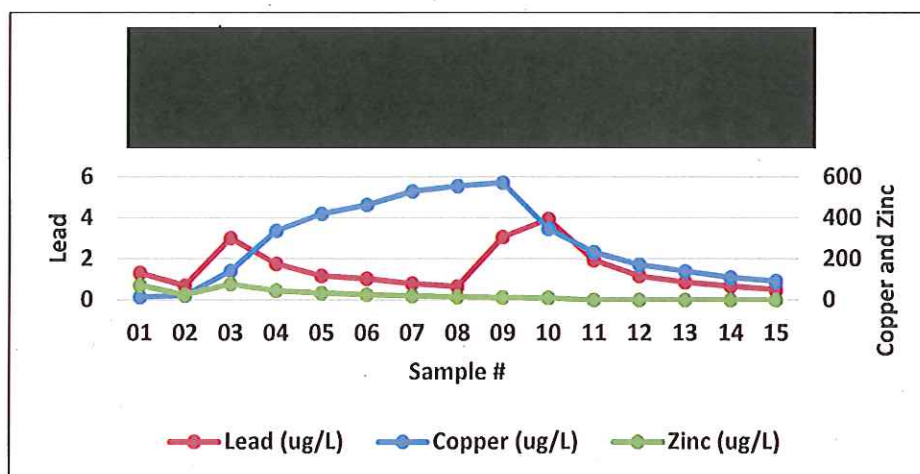
Following the replacement of the ██████████ original service line, a series of 15 sequential samples were collected from the kitchen tap to measure the lead levels and other parameters to ensure that the high lead from the original service line had not contaminated the interior plumbing at the ██████████ home. With the exception of two areas, lead levels were low throughout the ██████████ plumbing following the service line replacement. The two sources of lead that were still detected in the plumbing are likely the water meter (Sample 3) and the new external service shut-off valve (Samples 9-11). Although new brass plumbing components must be lead-free, there can still be some lead that is released from these components.

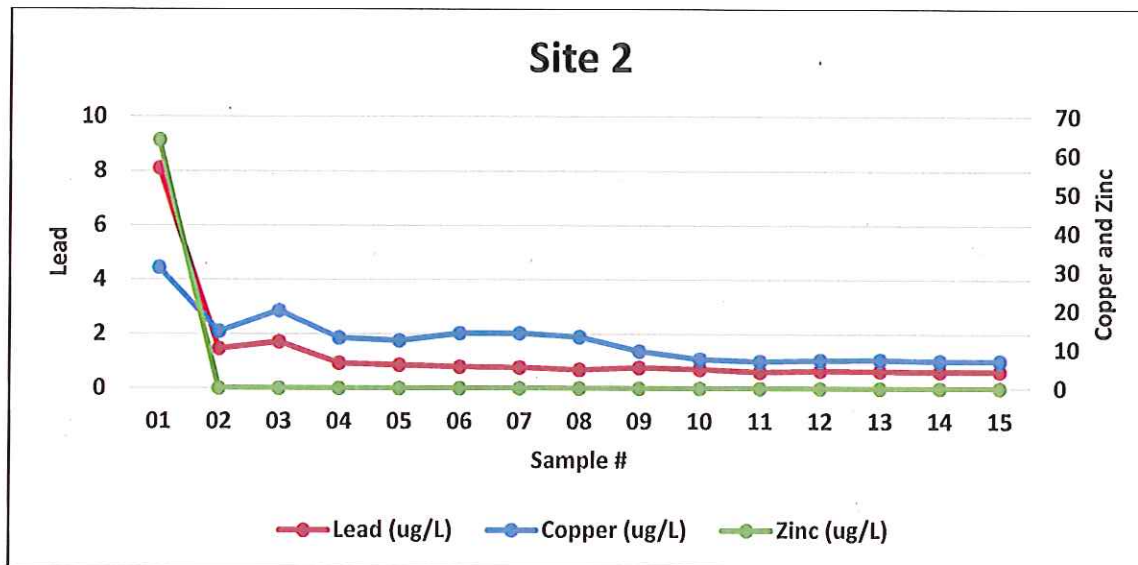
### Site #2 (Bryant Street)

Based on the results found at this home, it does not appear that any portion of the service line is made of lead, and as a result, the lead levels are low in most samples. The exception is in Sample 1 which reflects water within approximately 15 feet of the kitchen tap and is likely due to brass components in the faucet, underlying valves and fixtures.

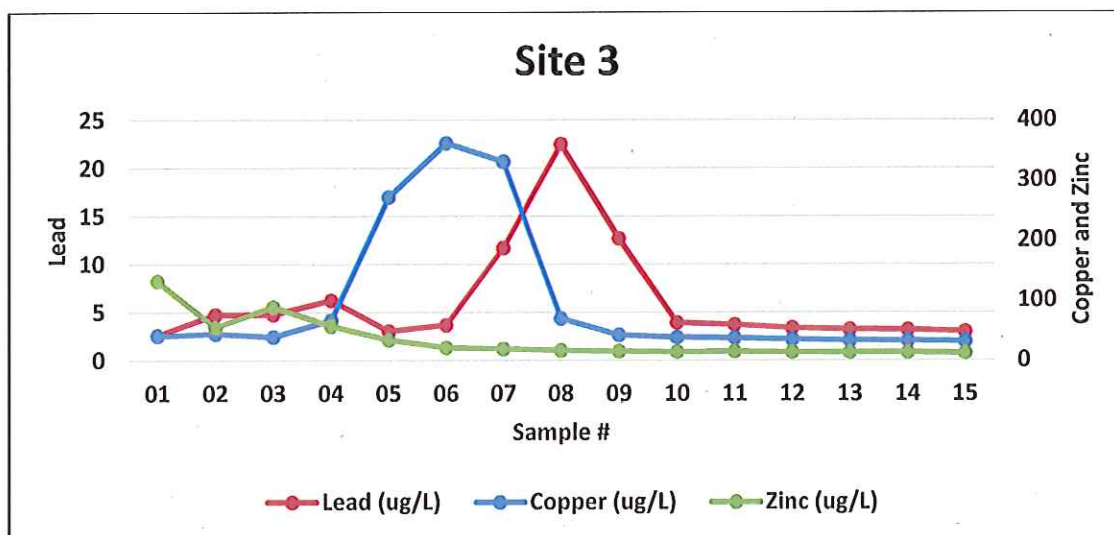
## Site #3 (Bryant Street)

Based on the results found at this home, it appears that the portion of the service line from the external service shut-off valve to the water main is made of lead as indicated by the increase in lead levels in samples 7 through 9.

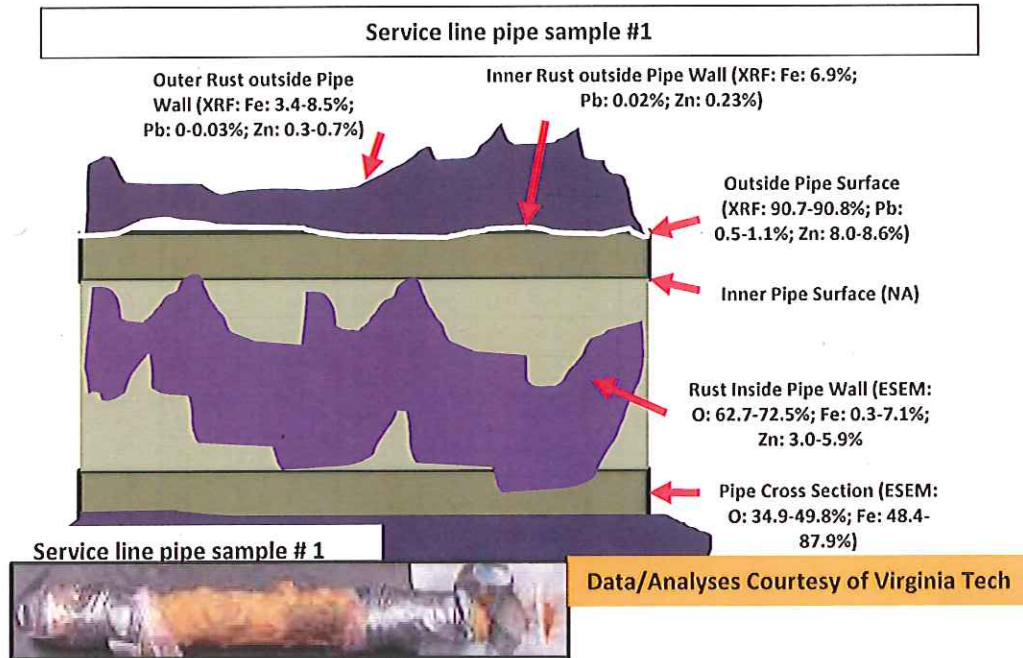
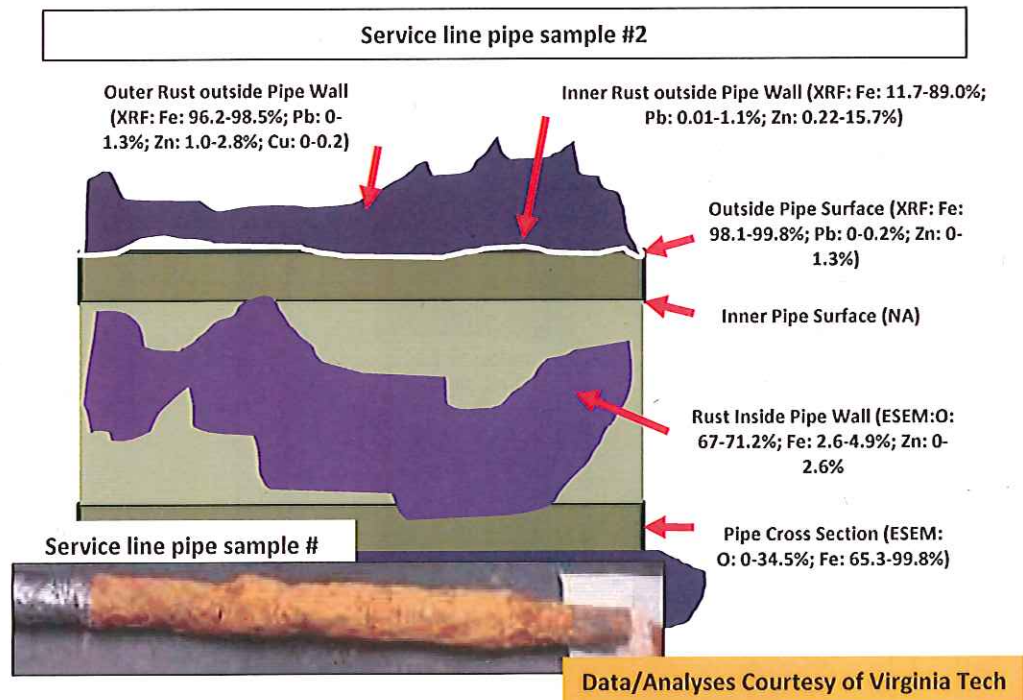
Below are the results of the galvanized pipe analyses conducted by Virginia Tech on the two sections of galvanized iron pipe from the [REDACTED] original service line. The analyses indicate that the [REDACTED] original service line was a typical galvanized iron pipe.

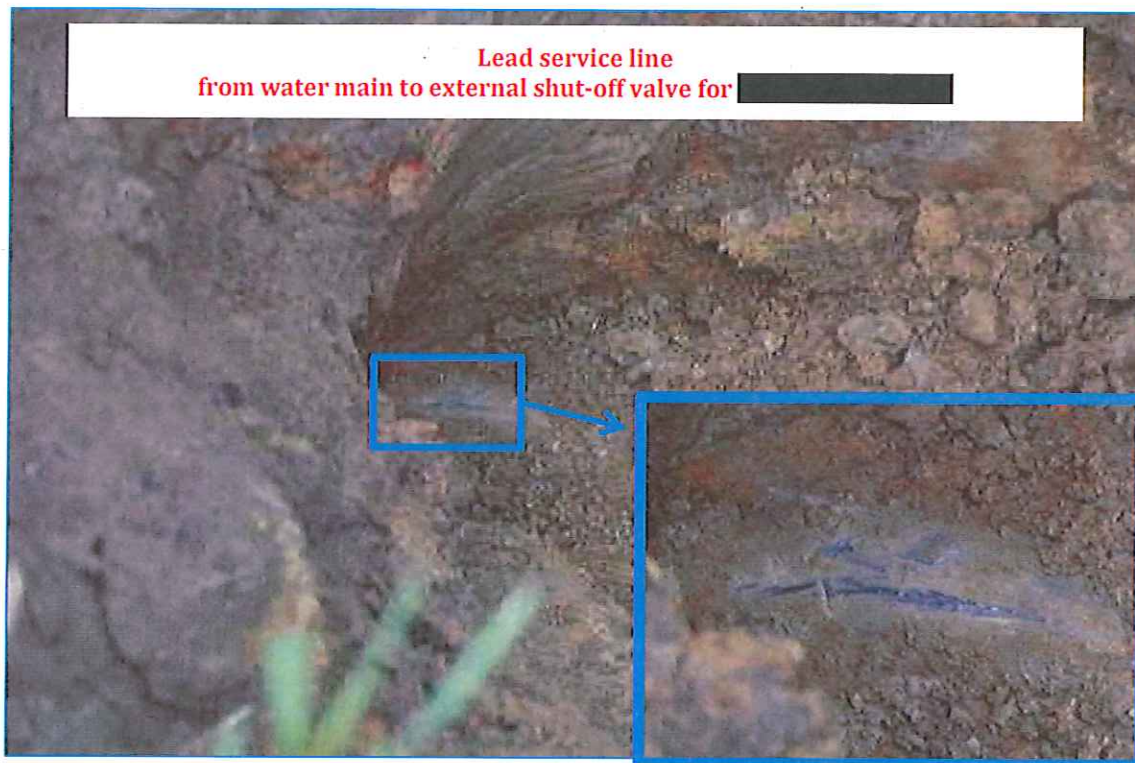
### Lead portion of the [REDACTED] original service line

Lead service lines can contribute up to 75 percent of the total mass release into the water. The portion of the [REDACTED] original service line from the water main to the external shut-off valve at the corner of [REDACTED] and Bryant Street is made of lead and is estimated to be approximately 25 feet in length.

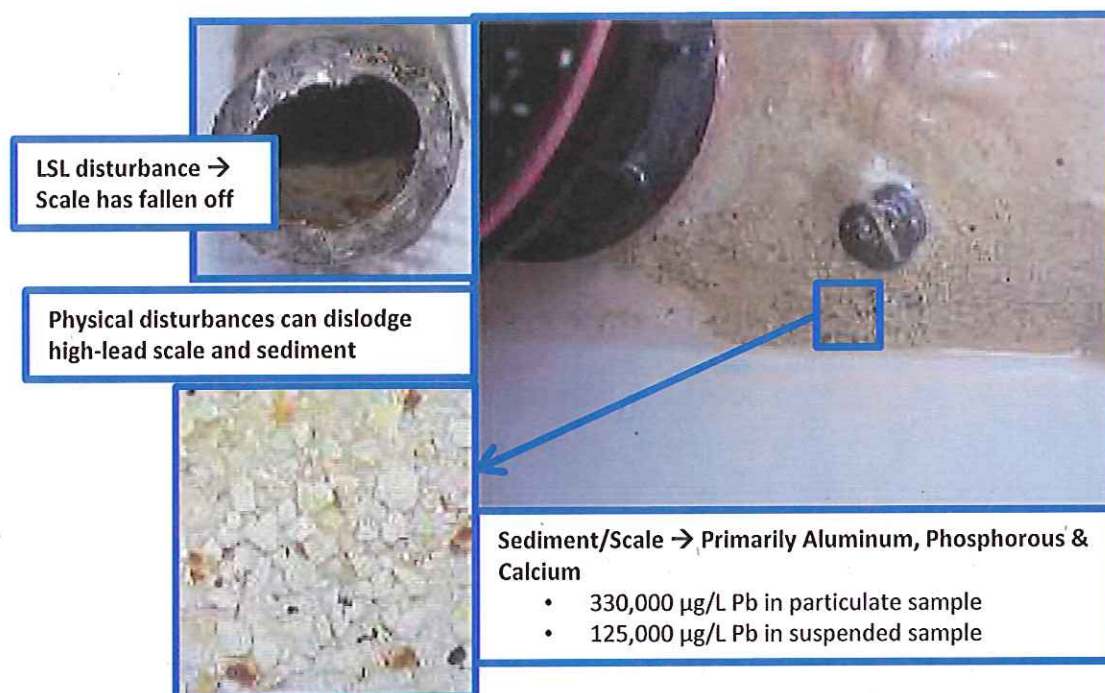
A recent EPA study indicates that physical disturbances in proximity to lead service lines can cause the dislodging of the protective scales from within the service lines. The photograph in Appendix C shows the scale that was dislodged from inside a lead service line during routine maintenance work in another city due to a physical disturbance of the line. The dislodged scale and sediment contained a very high concentration of lead. At the time of the EPA visit to the [REDACTED] home, there were two patches of new asphalt visible on [REDACTED] along the parkway where the [REDACTED] original service line was located, indicating recent excavation and possible recent physical disturbances to the [REDACTED] service line (Appendix C). These potential disturbances were along the galvanized iron section of the service line and as noted above, research has shown that the presence of lead pipe upstream can 'seed' the galvanized iron pipe downstream with lead, which results in an accumulation of lead-bearing scales within the galvanized pipe downstream of the lead portion of the service line. It is reasonable to assume that these physical disturbances to the galvanized iron portion of the service line could therefore result in the same dislodging of scale and sediment as studies have shown can happen with lead service lines.

A recent EPA study indicates that physical disturbances to lead service lines or in proximity to lead service lines can cause the dislodging of the protective scales from within the lines. The photograph below shows the scale that was dislodged from inside a lead service line during routine maintenance work in another city due to a physical disturbance of the line. The dislodged scale and sediment contained a very high concentration of lead.

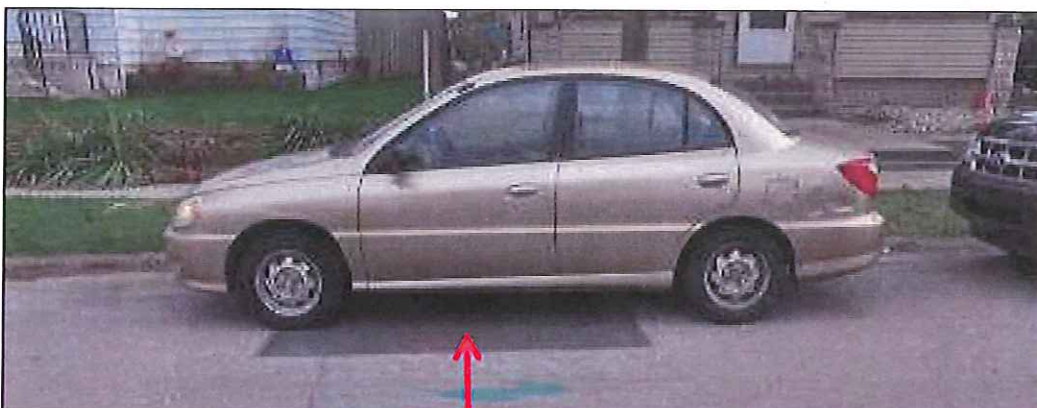
While visiting the [REDACTED] home, two fresh patches of asphalt were seen along the parkway where the [REDACTED] original service line was located. The jarring and vibration associated with excavation can dislodge the high lead-bearing scales from within the service line pipes.

Recent patch (#1) of asphalt along curb next to the parkway where the [REDACTED] service line runs.

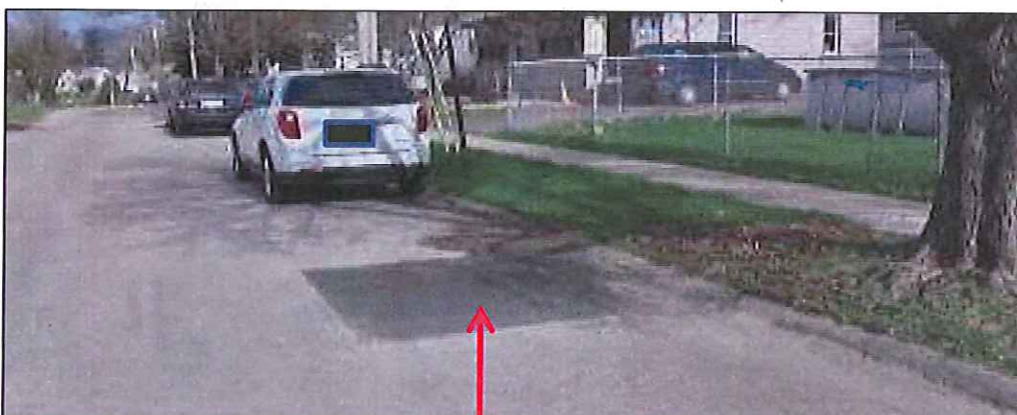
Recent patch (#2) of asphalt along curb next to the parkway where the [REDACTED] service line runs.

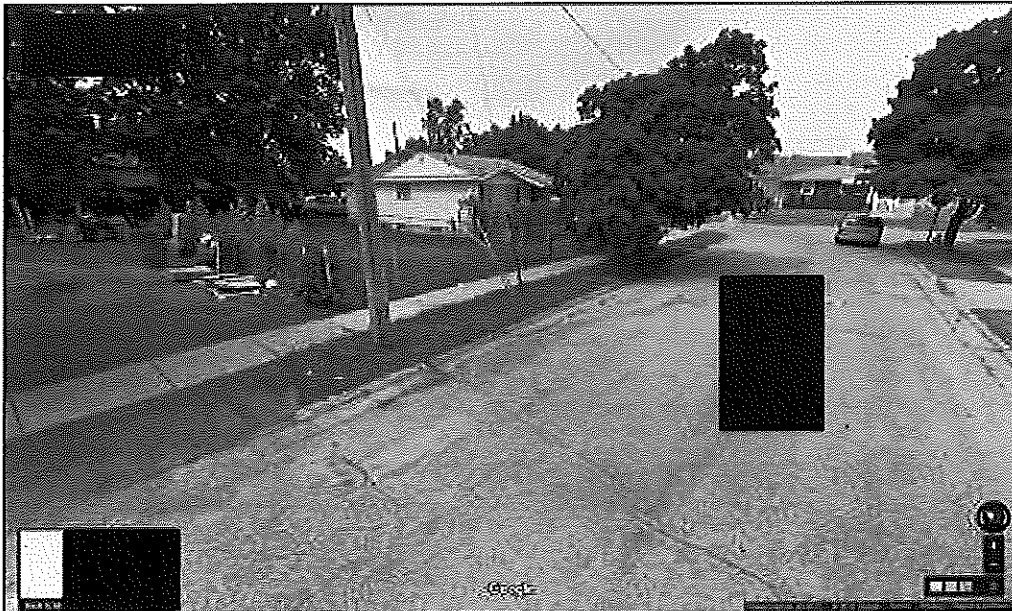
July 2011 image [REDACTED] (view from [REDACTED] toward Bryant Street).

Google 'Street View' Image 1 captured in July 2011 shows no patches in street along curb next to the parkway where the [REDACTED] service line runs toward Bryant Street, indicating that the physical disturbances occurred after the date this image was captured (July 2011).

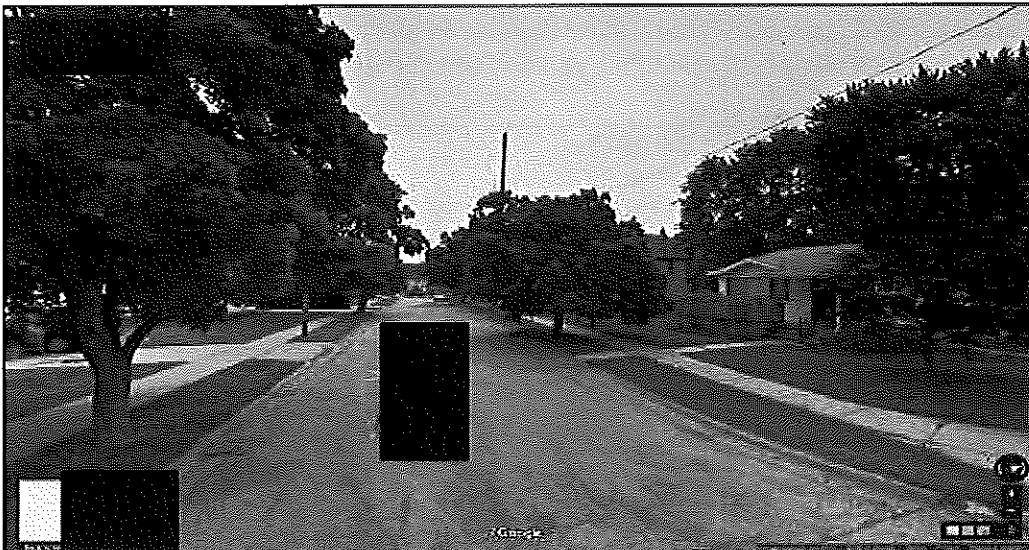
July 2011 image of [REDACTED] (view from Bryant Street toward [REDACTED]).

Google 'Street View' Image 2 captured in July 2011 shows no patches in street along curb next to the parkway where the [REDACTED] service line runs toward Bryant Street, indicating that the physical disturbances occurred after the date this image was captured (July 2011).

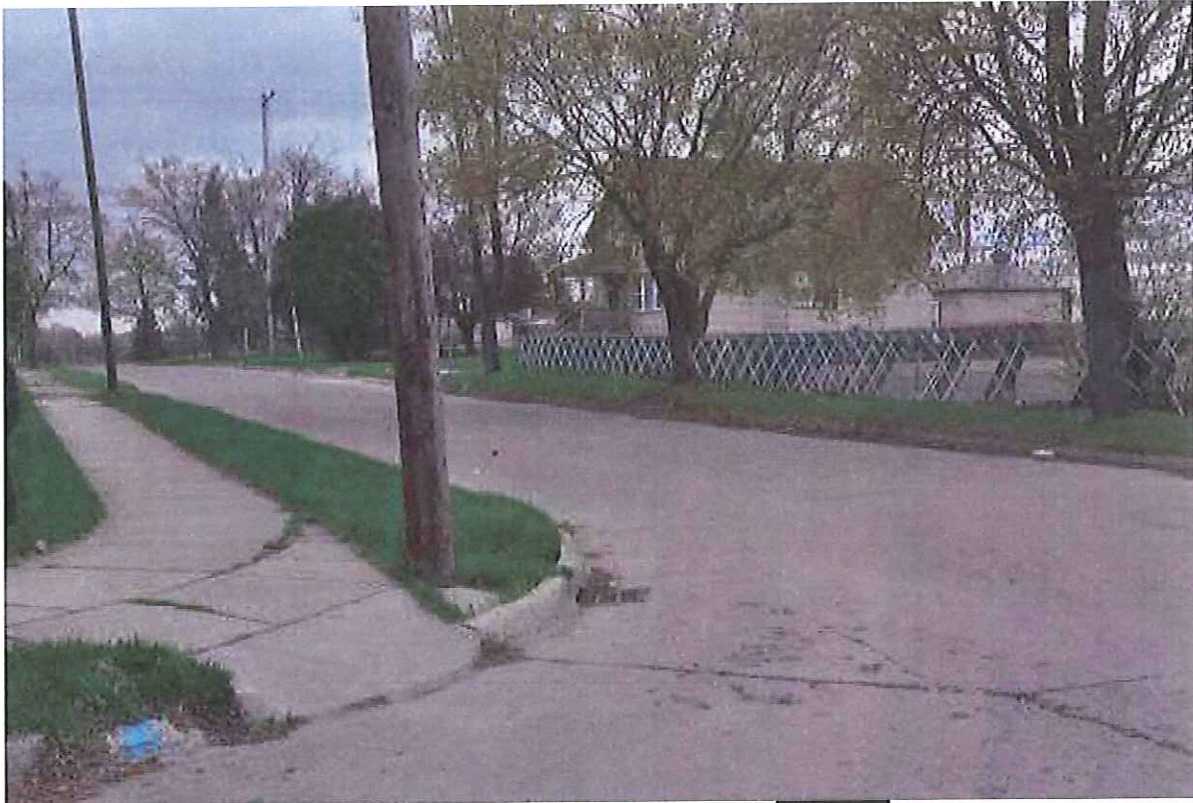
Corner of [REDACTED] and Bryant Street (location of [REDACTED] original external shut-off valve).

Photograph taken by EPA on April 27, 2015 shows no visible signs of physical disturbances in the vicinity of the lead portion of the [REDACTED] service line from the external shut-off valve to the water main on Bryant Street.
